DEPARTMENT OF TRANSPORTATION

Quality Assurance and Source Inspection

Contract #: 04-0120F4Cty: SF/ALA Rte: 80 PM: 13.2/13.9File #: 69.28**WELDING INSPECTION REPORT****Resident Engineer:**Pursell, Gary**Address:** 333 Burma Road**City:** Oakland, CA 94607**Report No:** WIR-016567**Date Inspected:** 28-Aug-2010**Project Name:** SAS Superstructure**OSM Arrival Time:** 700**Prime Contractor:** American Bridge/Fluor Enterprises, a JV**OSM Departure Time:** 1900**Contractor:** Zhenhua Port Machinery Company, Ltd (ZPMC), Changxing Island **Location:** Shanghai, China**CWI Name:** Mr. Li Jia**CWI Present:** Yes No**Inspected CWI report:** Yes No N/A**Rod Oven in Use:** Yes No N/A**Electrode to specification:** Yes No N/A**Weld Procedures Followed:** Yes No N/A**Qualified Welders:** Yes No N/A**Verified Joint Fit-up:** Yes No N/A**Approved Drawings:** Yes No N/A**Approved WPS:** Yes No N/A**Delayed / Cancelled:** Yes No N/A**Bridge No:** 34-0006**Component:** Orthotropic Box Girder(OBG)**Summary of Items Observed:**

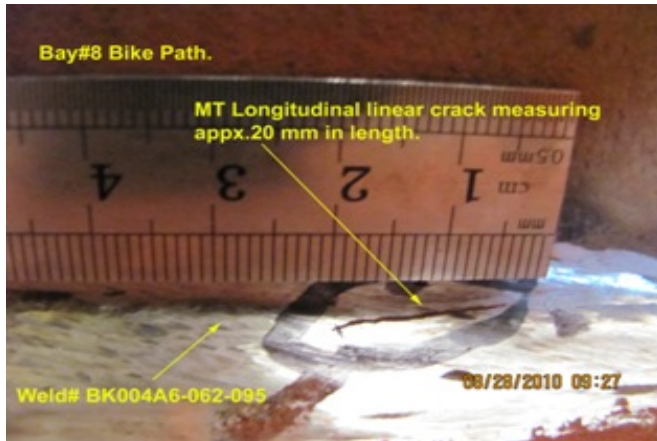
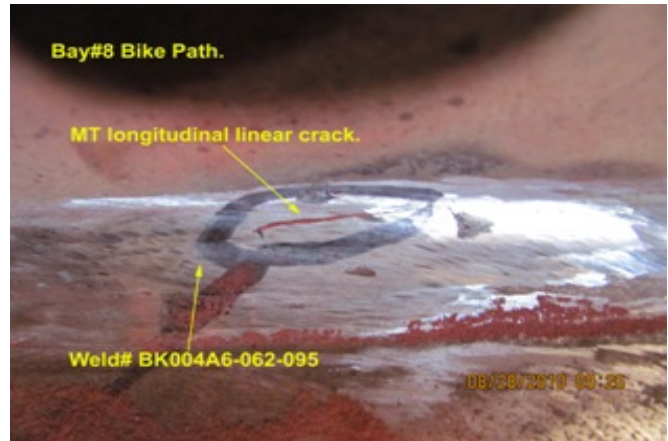
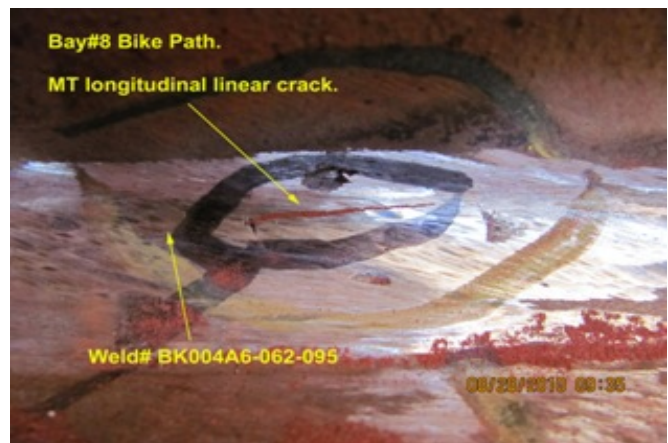
ZPMC Quality Control (QC) MT Technician was performing Magnetic Particle Testing (MT) for the Bike Path weld joint identified as BK004A6-062-095. This QA Randomly witnessed the MT. During random witness of MT this QA observed ZPMC QC MT Technician found one (1) longitudinal linear crack measuring approximately 20 mm in length. The "Y" location for this crack is 3050 mm from the nearest end of the weld. This QA informed to ZPMC QC Certified Welding Inspector(CWI) identified as Mr.Liu Fa Wen and American Bridge/Fluor (AB/F) QA Inspector Mr. Liu Hua Jie. Mr.Liu Fa Wen and Mr. Liu Hua Jie informed this QA that the Crack would be corrected in a manner compliant with the contract documents. Refer the attached photos for further information.
